Commonly Found Problems

Existing Façade Improvement Tips

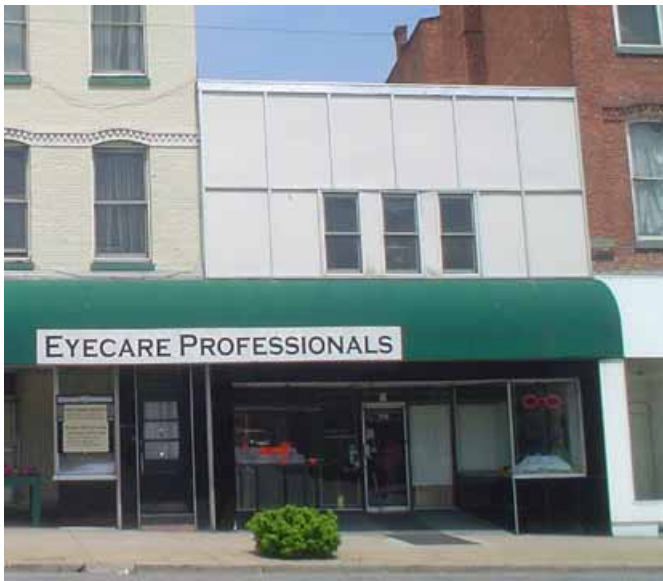
A large majority of the older buildings in the midtown area have had much of their original architectural design covered over with new cladding. Often times the new cladding is placed directly over the existing materials and conceals the historic façade behind it. This is most commonly found at the first-floor storefront level. Usually these newer materials are of cheaper quality and have little or no depth or detail to them. The result is a loss of architectural scale, historic

Concealing original façades behind newer materials often results in a loss of architectural detail, scale and character.

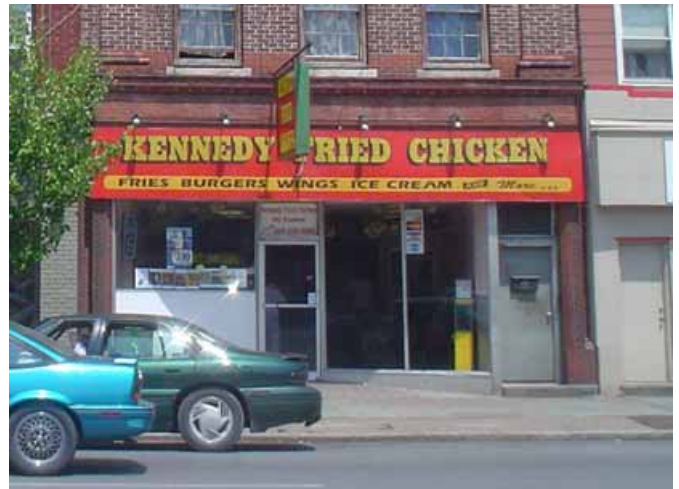
Many of the building fascias in the area have been covered over by large blank panels which act as a “billboard” for a business sign. These panels often have little or nothing to do with the architecture of the building, and tend to create a strong horizontal influence where there was none previously. Many of these buildings have an original fascia area which is specifically designed to frame lettering, but these are ignored for the larger sign real estate. Contrary to popular belief, bigger isn’t always better. Overall, the large billboard signs compete with each other for

Billboard type signs are typically larger than they need to be. Because they do not fit with the architecture of the building, they are often out of scale with the building and cover up parts of the facade, making it look out of place.

attention, and tend to create visual clutter in the neighborhood. Instead, the use of smaller, more artfully designed façade lettering will give the neighborhood a cleaner appearance and create a more charming area to shop.

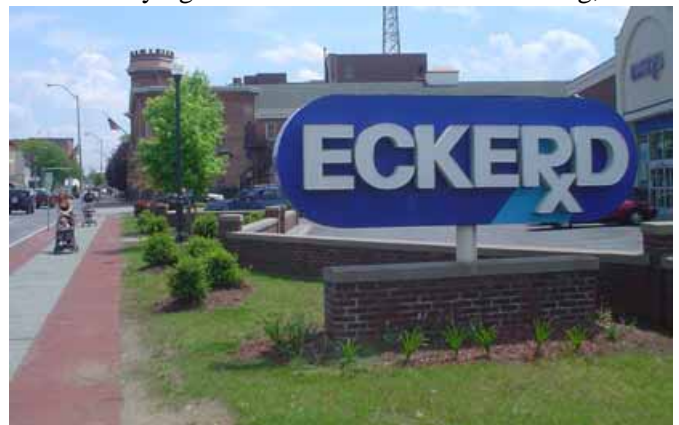
In an urban environment where people are typically never farther than 30 feet from the front of a building it is unnecessary to have freestanding business signs. Such signs are instead used along highways and strip development where they must be readable at greater distances and speeds. Most commercial chains have gotten into the habit of using them everywhere as a means of vying for attention and free advertising, when

Large signs such as this are designed for visibility in vehicles traveling at higher speeds than what is typically expected in a downtown neighborhood, and can actually encourage motorists to speed.

in fact they mostly just clutter the neighborhood. Another by product of these large signs is that it encourages us to drive at higher speeds. Such free standing signs should be removed in the Midtown area and replaced with façade lettering more in keeping with the scale of the neighborhood.

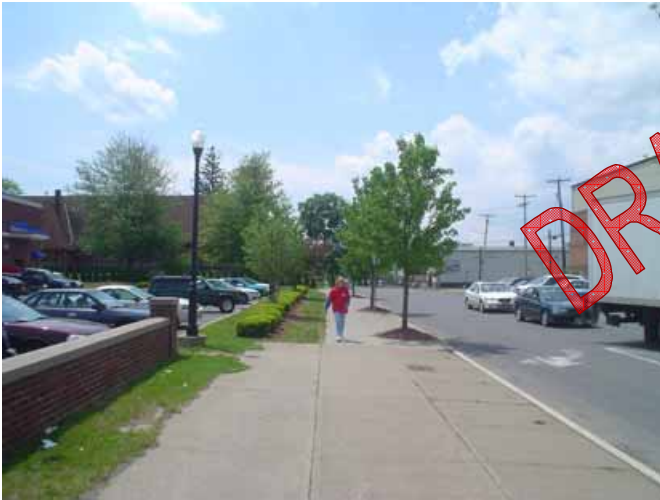
Having parking lots in front of buildings erodes the visual character of the street since there are no facades to define the street wall. Pedestrians walk along strips of sidewalk with cars on either side of them, and have no direct connection to the stores.

A number of newer buildings constructed in the area have been set back far from the street to make room for a parking area in front of the building. The suburban concept of setting a building back from the street and placing parking in front erodes the urban street wall which gives a historic city much of its character. The rhythm of building facades along a road and the outdoor space it defines is an important part of the urban experience, and allows us to create special outdoor spaces or highlight important buildings. The only buildings which should be set back far from the street are important civic institutions such as a school or Town Hall. Similar outdoor spaces such as a small park or greenspace are defined in a similar manner. In order to maintain the character of the historic city, buildings should be placed consistently up near the road, with parking in the side or rear whenever possible.

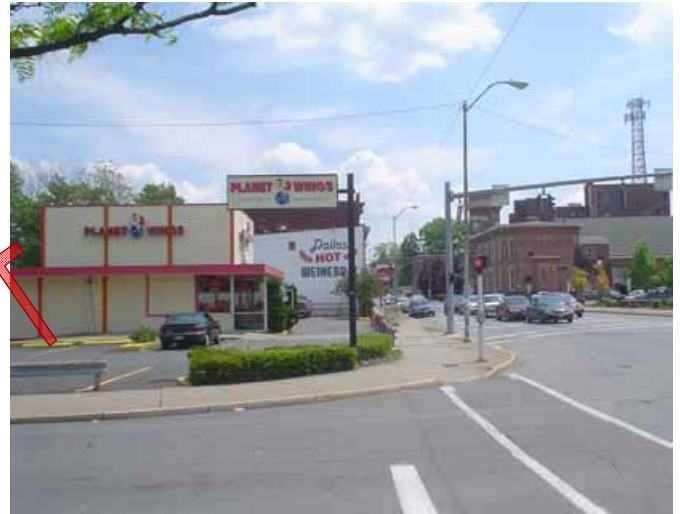
Similar to the concept of maintaining the street wall, corner lots are especially important in defining the intersection. Almost like an anchor, these buildings are generally more prominent in design and style, and help

to anchor the end of a city block. These empty corner lots are key areas for redevelopment, and would benefit from the highly visible location.

Corner buildings are also important in defining the street wall and the highlighting road intersections - without them, the city blocks have no visual beginning or end. Buildings should be placed here instead to focus attention on the building and the architecture, not a parking lot.

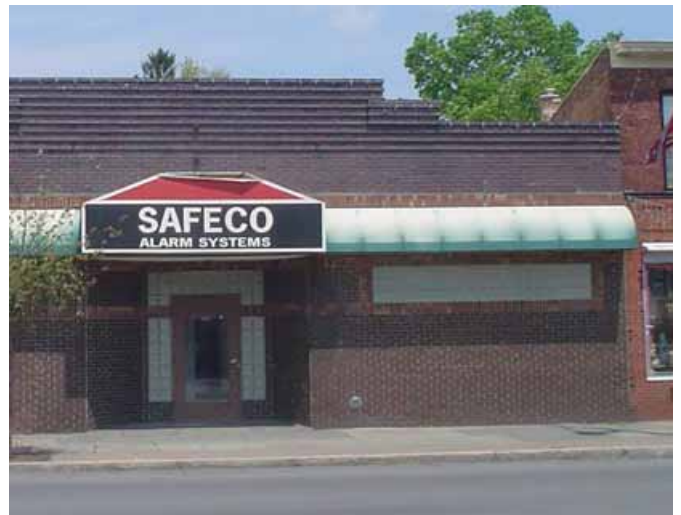
Blank or otherwise unadorned facades at the pedestrian street level create an unfriendly and harsh atmosphere. Ground floor facades especially should be open and inviting, with large window areas and recessed entryways.

Blank or windowless facades, especially at the ground floor level, create an unwelcome pedestrian atmosphere.

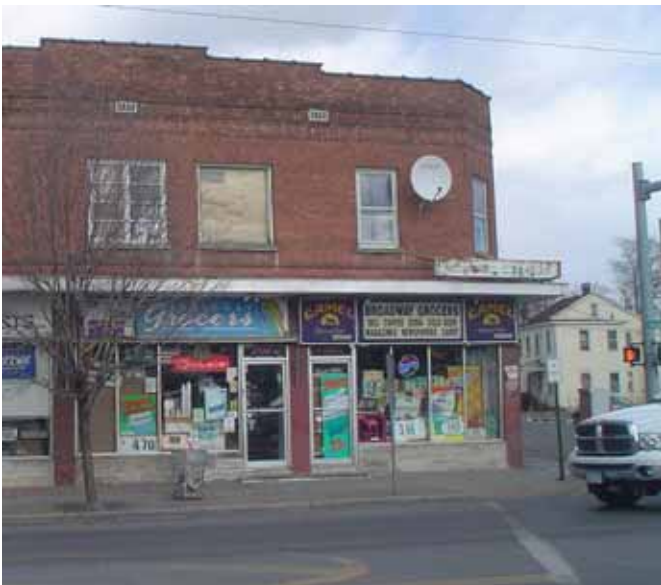
A large number of buildings in the midtown area have satellite dishes and similar equipment mounted directly to their facades, in some cases two or three per building. This type of equipment clutters the façade and distracts from the architectural character of the neighborhood. These utilities should be relocated on the roof or other areas which are not readily visible from the street.

The architecture and charm of this building is hard to appreciate when the observer is distracted by so many signs, posters, advertisements and even satellite dishes which clutter the outside.

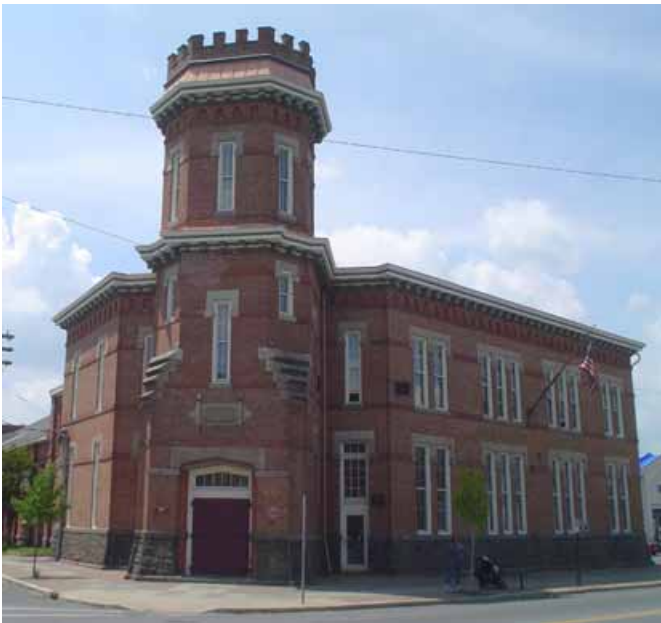
Historic architecture

Like much of Kingston, the Midtown area has a diverse mix of older historic buildings which help define its character. These buildings are a great asset to the city, and a foundation for its future growth and vitality. The Rondout neighborhood is a perfect example of how these older neighborhoods can be restored into lively

and attractive places of business. The older buildings found in Midtown are potentially places of a similar redevelopment effort. However, if any of these older buildings are lost, they will be gone for good, so they should be maintained and preserved as much as possible.

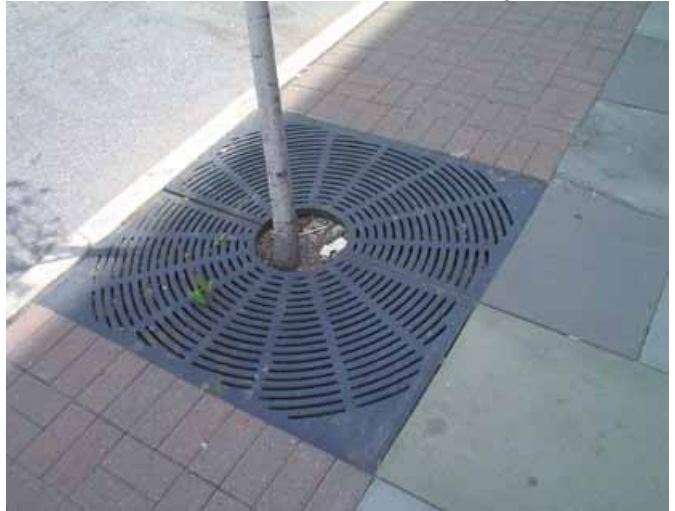
New sidewalk designs

In lieu of the standard pored concrete sidewalk commonly found, upgraded brick and stone sidewalks have been installed and maintained along much of the

Broadway corridor, helping to give the area a unique appearance. This theme should be encouraged to continue whenever possible to maintain a consistent style and character.

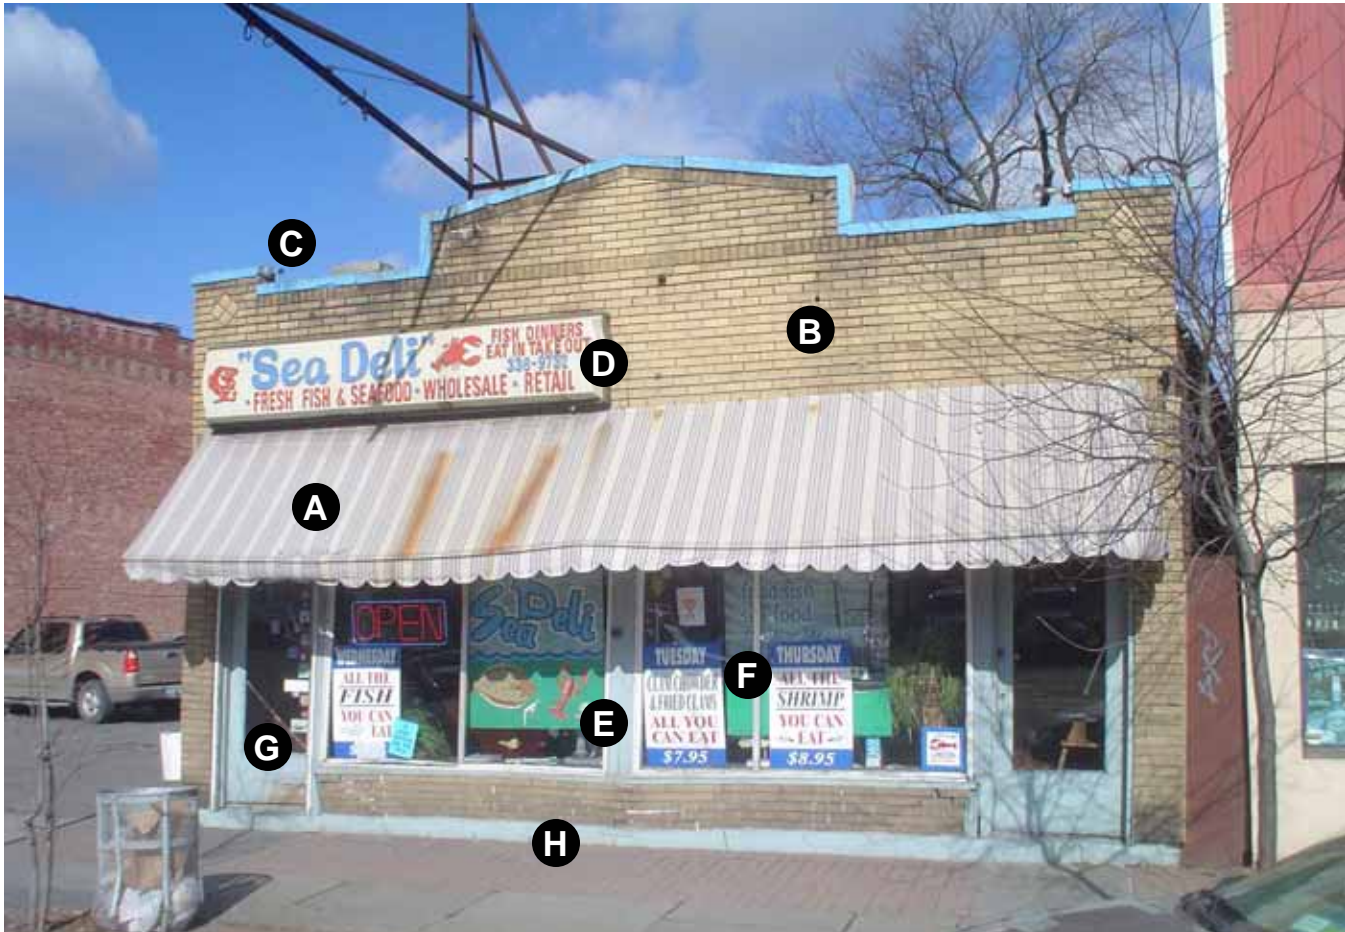
654 Broadway

A: The existing canopy is in extremely worn and faded condition, and has been stained by rust dripping from the sign above.

B: The existing masonry façade has accumulated years of dirt, has been discolored by pollution, and needs a good cleaning. Additionally, some of the mortar joints and bricks are in need of repair or repointing.

C: The existing concrete parapet caps are cracked and spalling. The paint on them has faded and is peeling.

D: The existing business sign is very old and weathered. Additionally, the sign itself is somewhat cluttered with information and squeezed into a small area. Given the symmetrical layout of the façade, the sign would be better located in the middle rather than at the end up against the awning. Backlit signs such as this typically accumulate moths and dirt inside which gives it an unclean appearance at night, and they generally require more maintenance in cleaning and bulb replacement.

H: The existing concrete step along the front of the building is chipped and cracked in places, and could use a fresh coat of paint.

A: Replace the existing awning with a new one which sets a new standard color scheme for “Sea Deli” blue.

B: Scrub and clean the existing masonry façade. Repoint mortar joints.

C: Patch or replace the existing concrete parapet caps. Paint them in the new “Sea Deli” blue.

G: Replace the existing wood storefront construction with new painted aluminum storefront to match the “Sea Deli” blue color scheme. Replacing the old glass with newer, more energy efficient panes could help reduce energy costs as well. Alternately, repair the existing wood storefront construction as it is, sand and repaint.

I: Replace the existing wood doors with new anodized aluminum storefront doors. Alternately, repair the existing doors as needed – sand and repaint.

J: Patch and repair the existing concrete step along the front of the building. Repaint as needed.

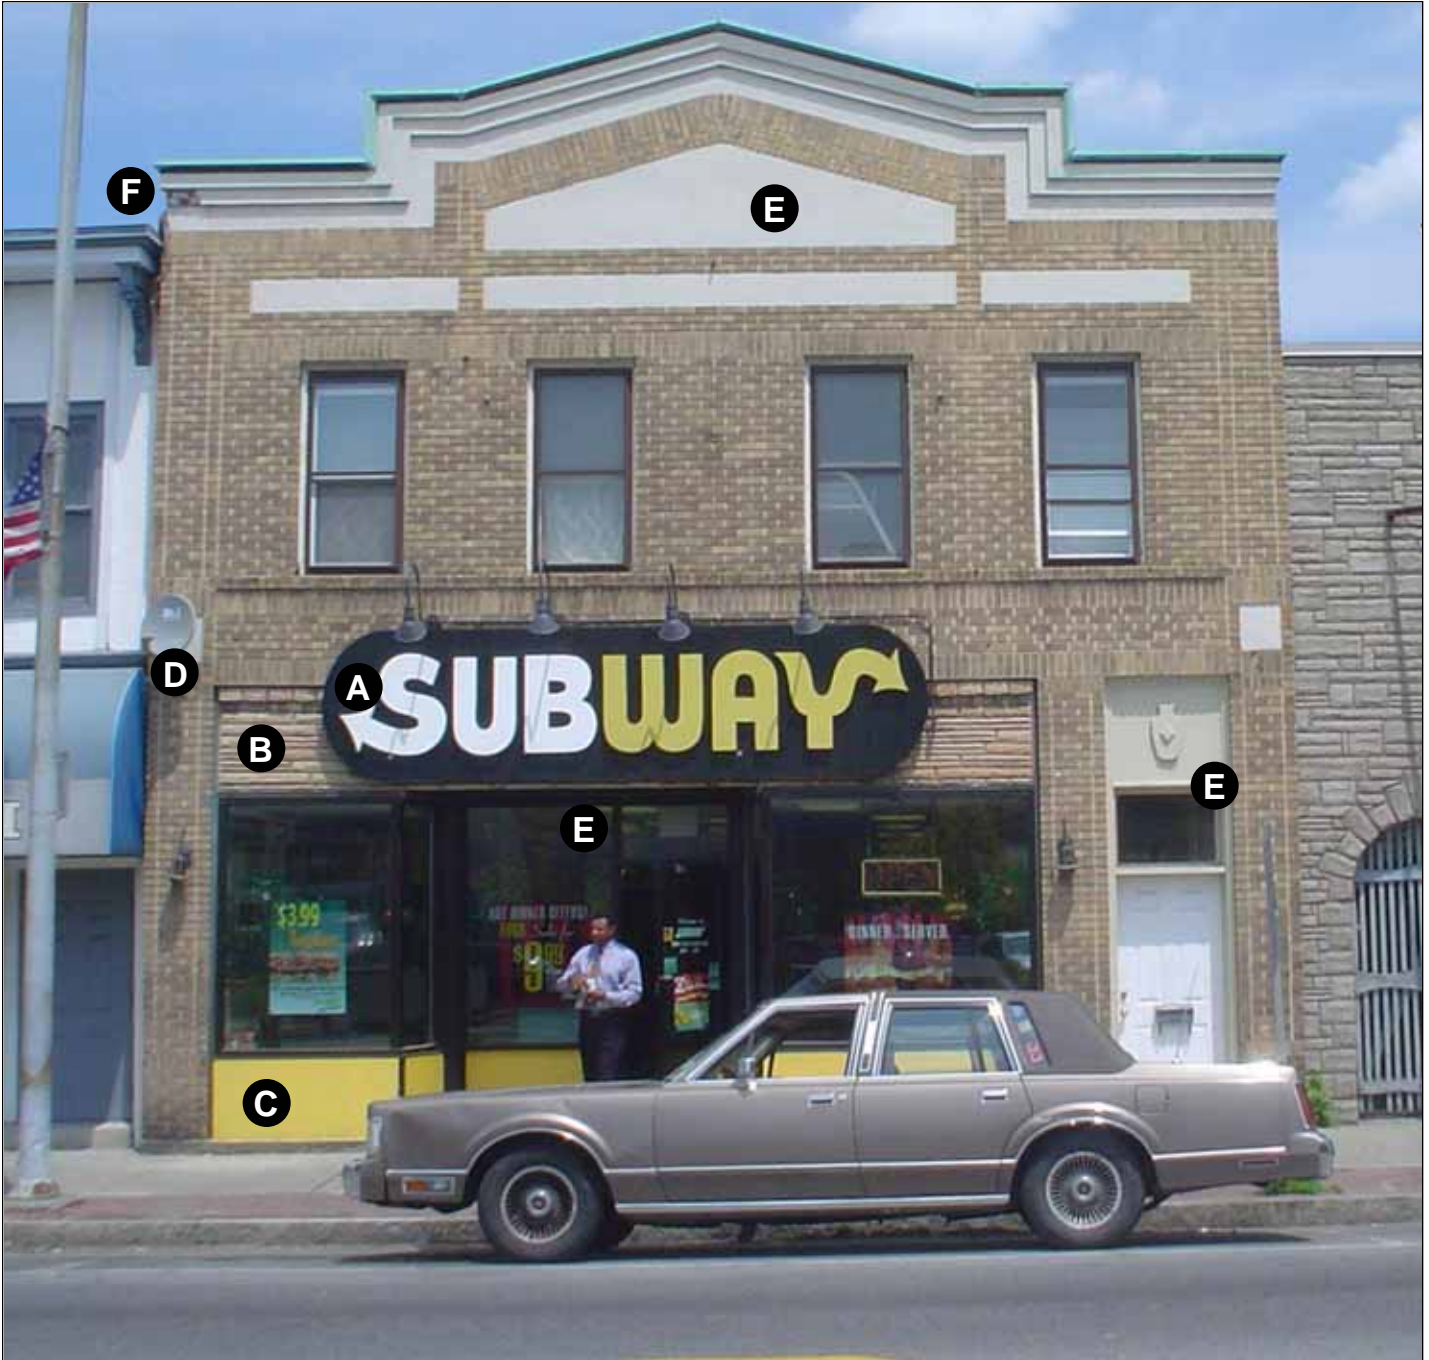
484 Broadway

A: The bold and overly large sign overwhelms the façade and ignores the underlying architectural design behind it.

B: The area above the existing storefront has been in-filled with an ashlar veneer pattern of masonry which has little to do with the original brick masonry façade. This area would traditionally be (and likely was previously) an ornamental wood design which would frame the letters of the business name

F: This plaster or stucco cornice appears to be cracking and falling away in certain places.

A: Replace the large sign board with smaller lettering which is applied to the facade and more suitable in size for reading from the street.

B: Cover or replace the ashlar veneer pattern above the storefront with a decorative wood trim panel that acts as the backdrop for the sign lettering.

C: Replace the bright yellow storefront panels with wood panels painted in a more muted or natural shade of color to match the other trim on the building. In this example, the bright yellow panels are replaced, but still display a yellow accent border which ties into the corporate color scheme of the business. This allows the recognizable company colors to still be used without overwhelming the façade.

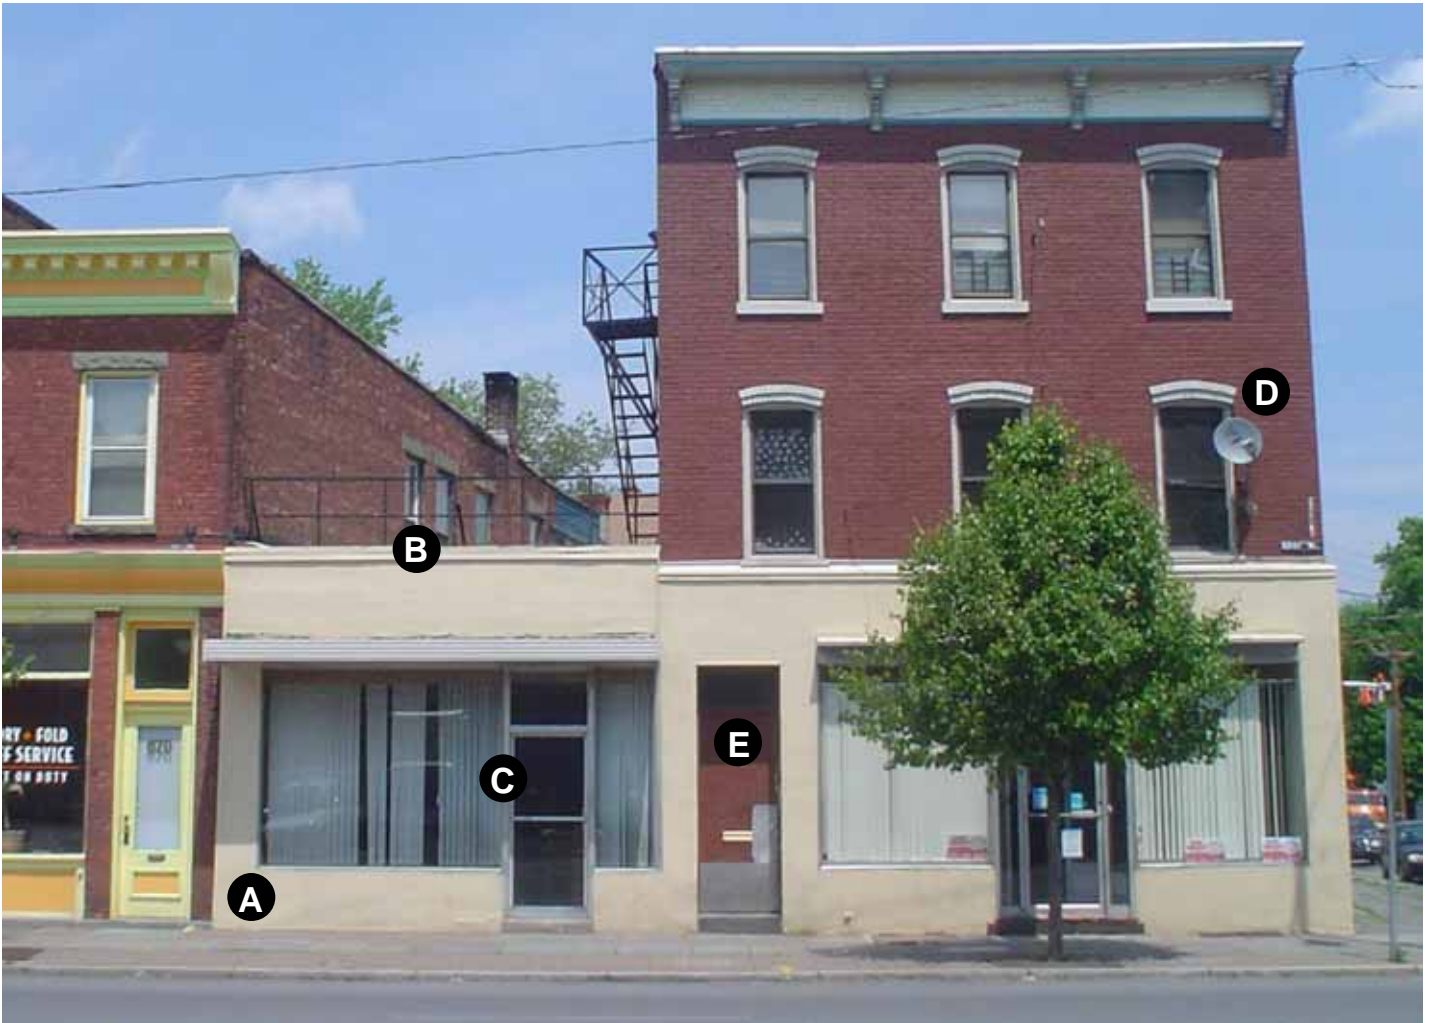
666 Broadway

A: Overall, the drab beige paint job looks dull and lifeless. Painting the entire surface of the façade this same color reinforces the perception that it is a flat texture-less surface with no articulation.

B: Bent metal flashing at the roof parapet is painted same beige color as the rest of the façade, causing it to blend in and be invisible instead of providing a visual cap to the roof.

A: Reinforce the idea of a “watertable” by painting a different color along the base, especially if there is a hard edge or line there to follow that gives the colors a logical place to stop.

B: Remove the old bare metal flashing and install new colored metal flashing that works into the color scheme of the rest of the façade.

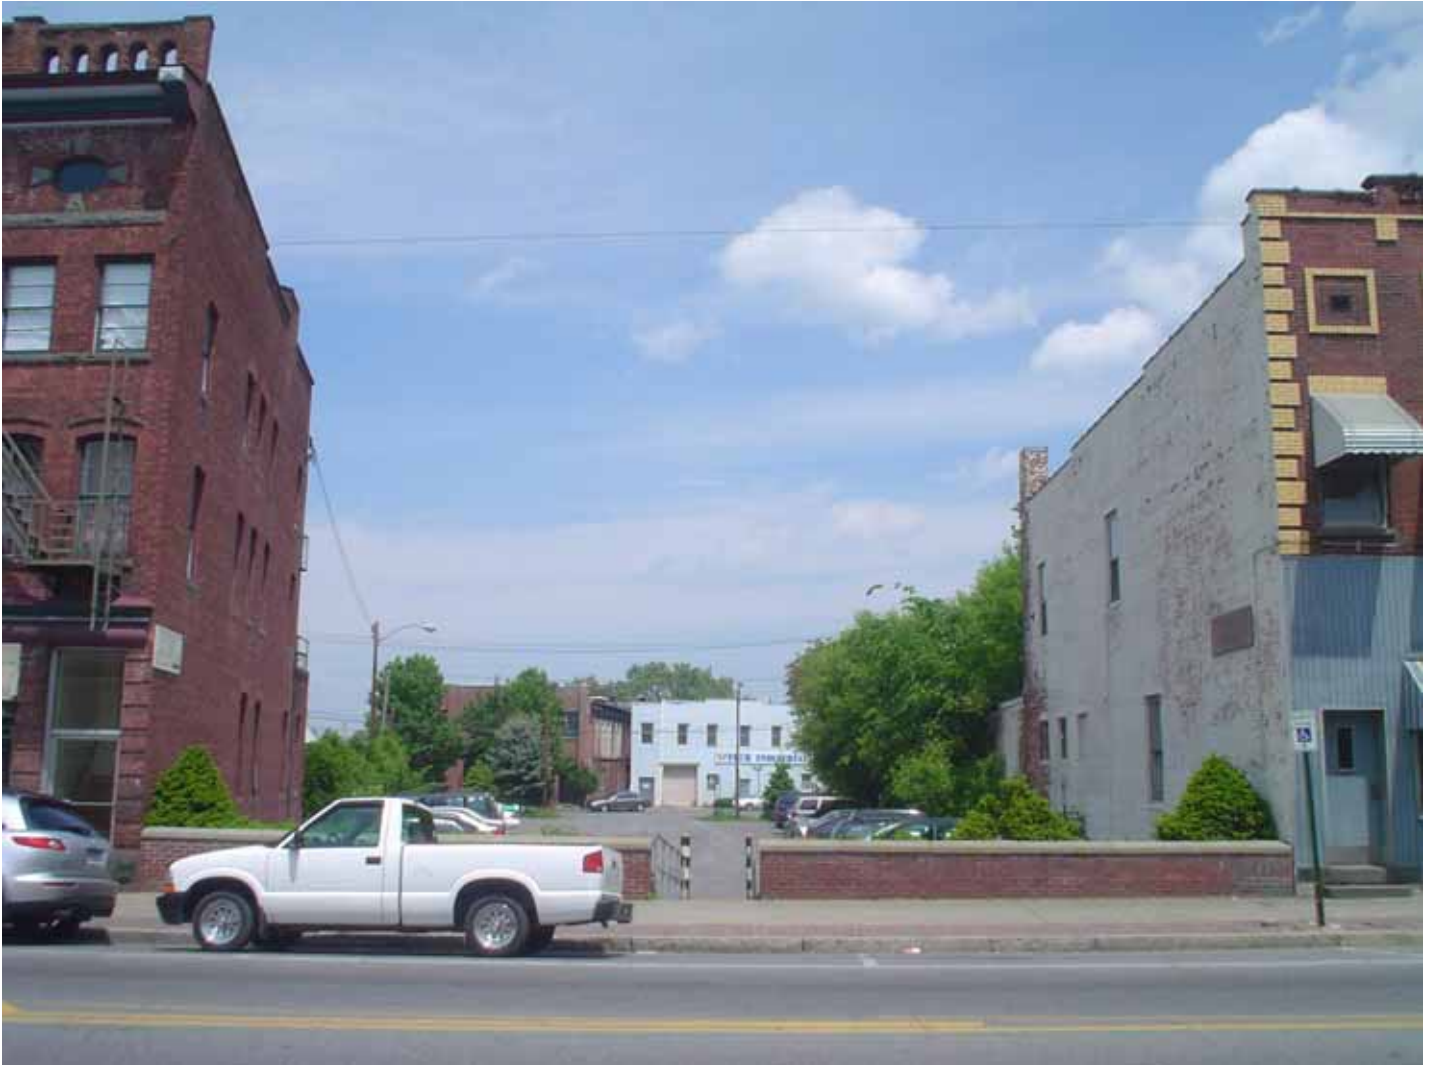
574 Broadway

A: Existing empty building lot is a “missing tooth” in the urban street wall which is currently only being used for parking. If a new building were to be proposed for this lot, careful consideration should be given to how it works with the older architecture of the street.

A: The ground floor storefront area – typically called the “Base” – is usually capped by a horizontal entablature. Whenever possible, this should try to align with similar features on adjacent buildings.

B: The top of the building should be capped by a strong cornice which has a lot of depth and shadows. When possible, this should try to align with design features on adjacent buildings.
